DEPARTMENT OF TRANSPORTATION**DIVISION OF ENGINEERING SERVICES**

Quality Assurance and Source Inspection

Contract #: 04-0120F4Cty: SF/ALA Rte: 80 PM: 13.2/13.9File #: 1.28**WELDING INSPECTION REPORT****Resident Engineer:** Casey, William**Address:** 333 Burma Road**City:** Oakland, CA 94607**Report No:** WIR-028678**Date Inspected:** 23-Oct-2012**Project Name:** SAS Superstructure**OSM Arrival Time:** 700**Prime Contractor:** American Bridge/Fluor Enterprises, a JV**OSM Departure Time:** 1730**Contractor:** American Bridge/Fluor Enterprises, a JV**Location:** Job Site**CWI Name:** As noted below**CWI Present:** Yes No**Inspected CWI report:** Yes No N/A**Rod Oven in Use:** Yes No N/A**Electrode to specification:** Yes No N/A**Weld Procedures Followed:** Yes No N/A**Qualified Welders:** Yes No N/A**Verified Joint Fit-up:** Yes No N/A**Approved Drawings:** Yes No N/A**Approved WPS:** Yes No N/A**Delayed / Cancelled:** Yes No N/A**Bridge No:** 34-0006**Component:** SAS OBG**Summary of Items Observed:**

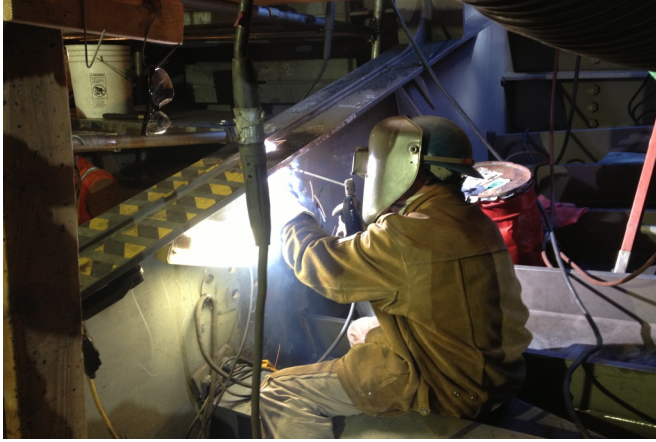
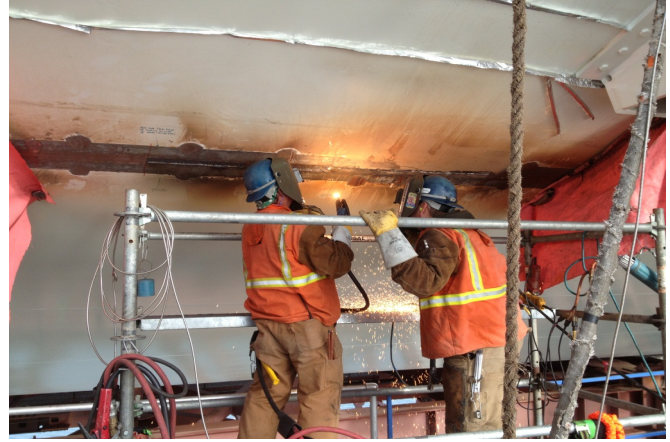
ABF welder James Zhen #6001 was observed performing ongoing weld repairs on weld 12E PP115.2-E2.3-PS2.

ABF welder Mike Jimenez #4671 was observed performing ongoing weld repairs on weld 12E-E2.1-C1.1 at y=7650. The dimensions of the excavation was noted as 250L/60W/10D. The welder was observed utilizing WPS ABF-WPS-D15-1004-Repair-Revision 0 for SMAW. The welder was observed preheating the welds prior to Carbon Arc Gouging and welding. Other welding parameters as inspected by QC Inspector appeared to be in compliance with the WPS noted above. RWR's 201210-013-016 were referenced for this weld repair.

ABF welder Jin Quan Huang #9340 was observed performing weld repairs on the longitudinal stiffener at 13E PP124.5-E5-LSE at y=20mm. The dimensions of the excavation was noted as 70L/35W/12D. The welder was observed utilizing WPS ABF-WPS-D15-1004-Repair-Revision 0 for SMAW. The welder was observed preheating the welds prior to Carbon Arc Gouging and welding. Other welding parameters as inspected by QC Inspector appeared to be in compliance with the WPS noted above.
